PRELIMINARY INVESTIGATION IN J33 TURBOJET ENGINE OF SEVERAL  
ROOT DESIGNS FOR CERAMAL TURBINE BLADES

By George C. Deutsch, Andre J. Meyer, Jr.  
and William C. Morgan

Lewis Flight Propulsion Laboratory  
Cleveland, Ohio

January 26, 1953

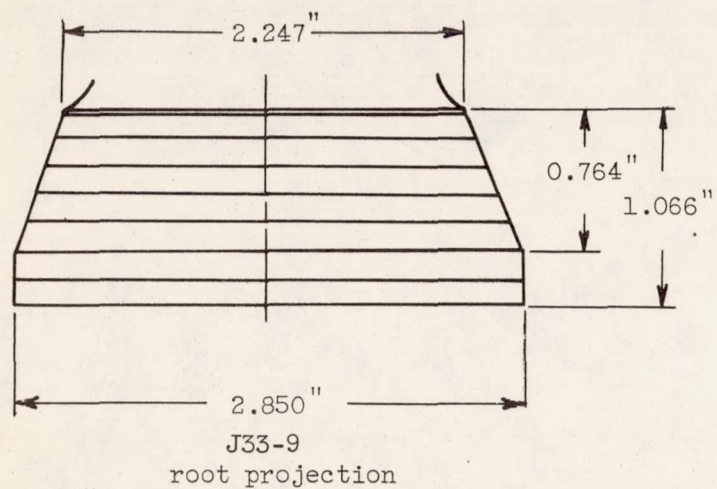
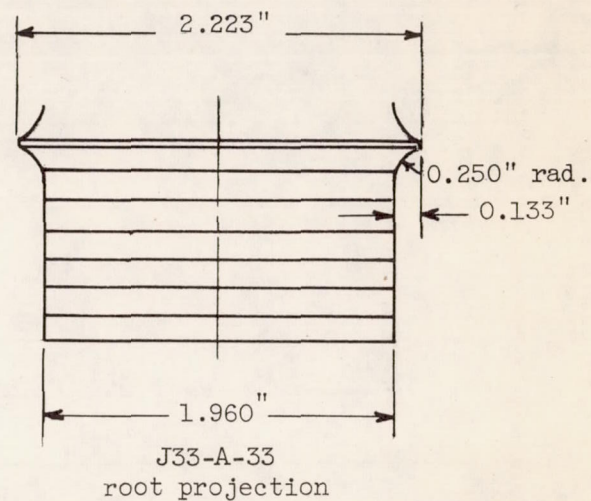
Figure 1. - Projections of J33-A-9 and J33-A-33 turbine roots.

Root design. - In changing from the J33-A-9 to the J33-A-33 engine the root profile was kept the same but the width was reduced (fig. 1). For the standard fir-tree-type root, this change plus the slight increase in blade length resulted in an increase in the stress across the top serration of from 8900 pounds per square inch to 11,400 pounds per square inch at rated speed for a ceramal blade having a reported density of 6.0 grams per millileter.

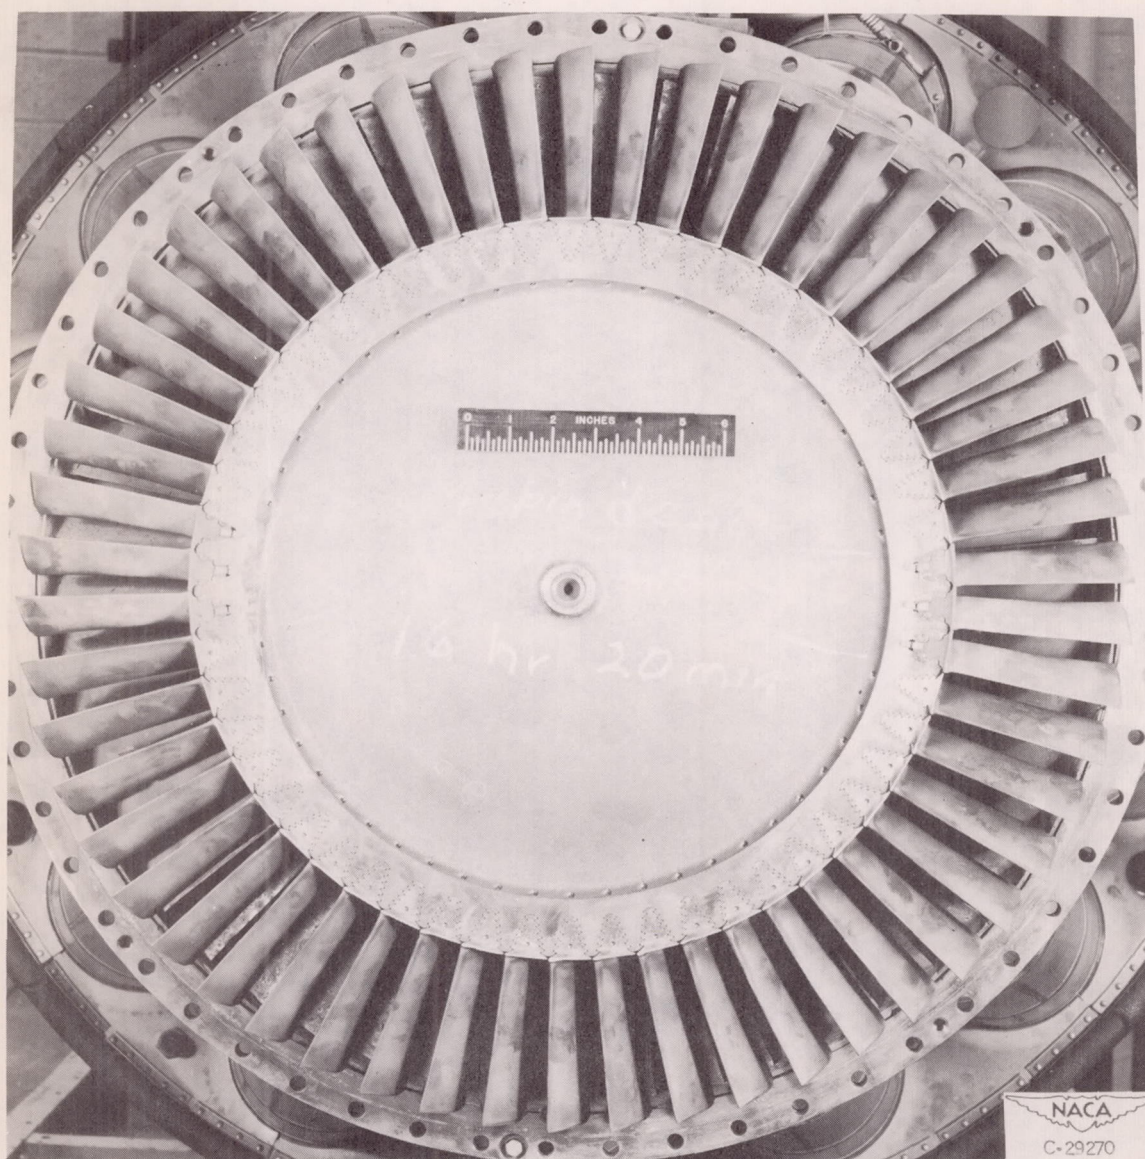
4-pin blade runs. - As in the previous run this wheel was bladed with two diametrically opposed clusters of three ceramal turbine blades (fig. 9). After 1 hour and 40 minutes of operation the fuel pump to the

Figure 9. - Ceramal turbine blades having 4-pin type roots prior to operation.
